ecology and environment. inc.

Date: April 22, 1994

Subj: Site Assessment: TRI Container
Catoosa, Rogers Co., Oklahoma
TDD#: T06-9311-011
PAN : EOK0419SA

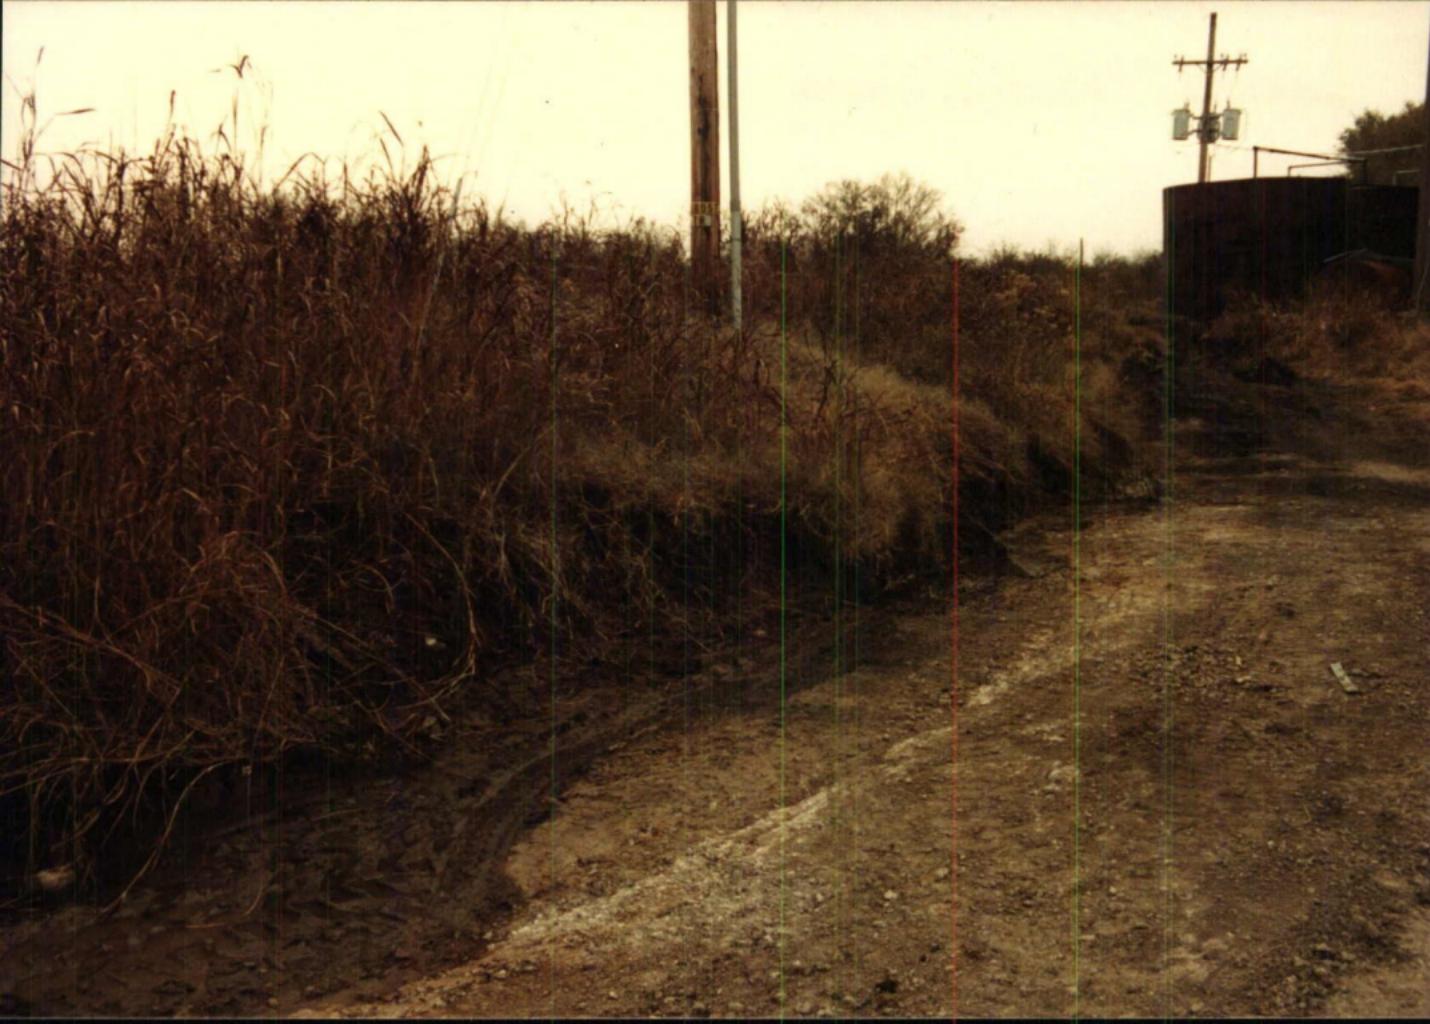
SITE NAME: TRI CONTAINER, INC. TDD#: T06-9311-011
PHOTO#: 105 PHOTOGRAPHER/WITNESS: NEELEY/LONG/BANIPAL
DATE: 11/09/93 TIME: 1038 DIRECTION: SE
EXCAVATED SPILL AREA.

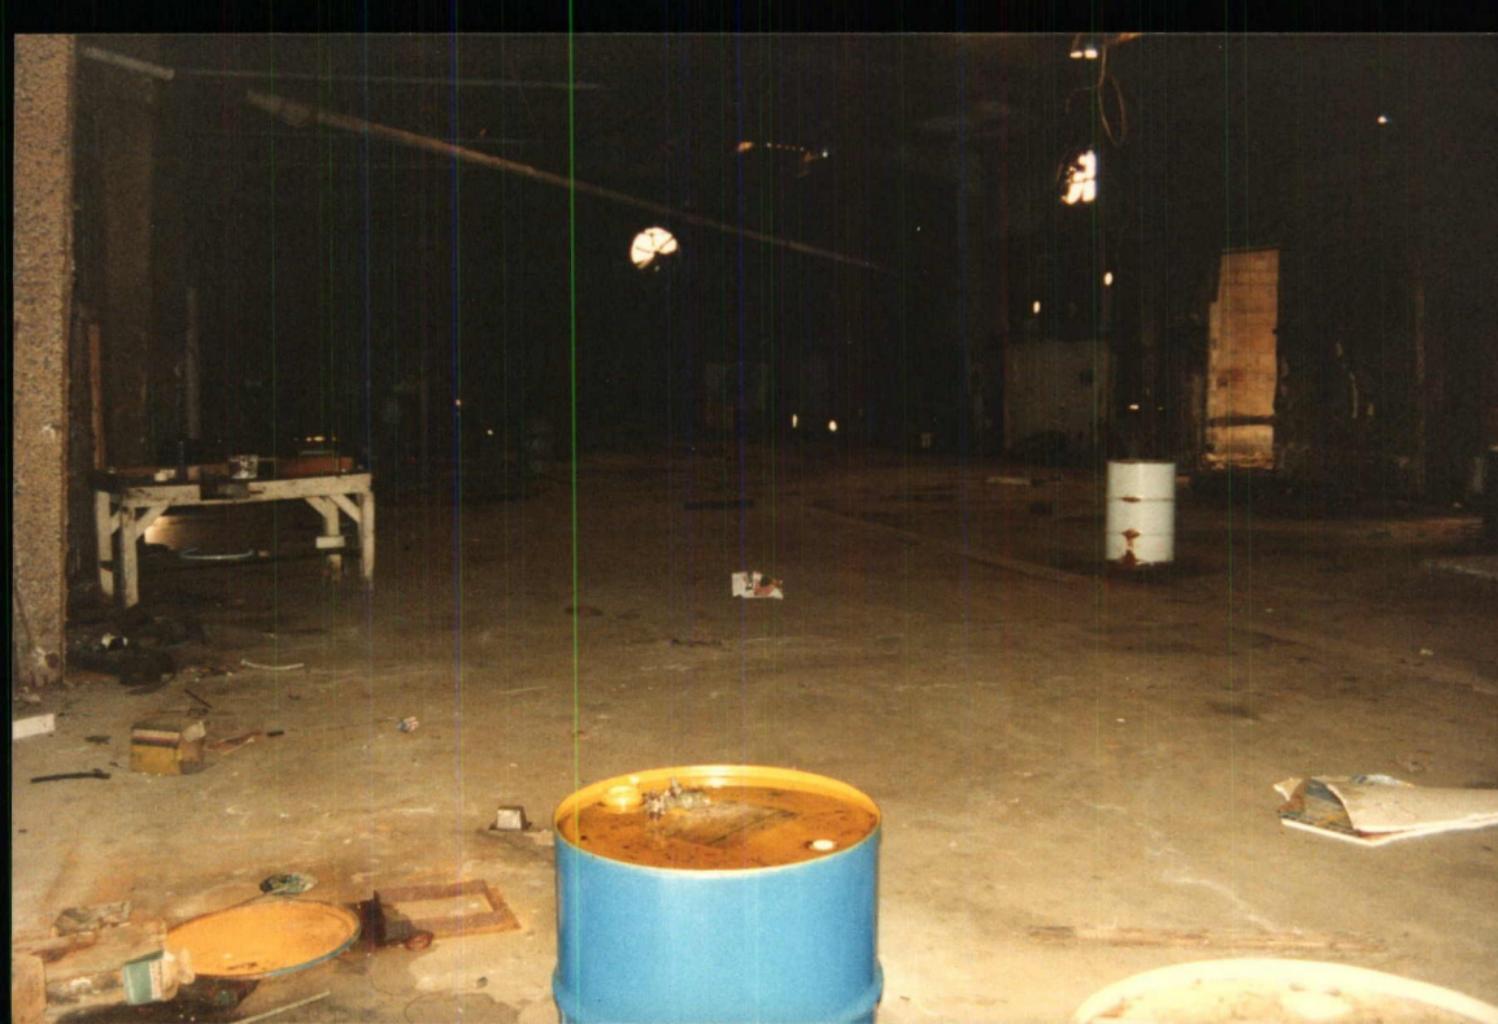
SITE NAME: TRI CONTAINER, INC. TOD: T06-9311-011
PHOTO #: 109 PHOTOGRAPHER/WITNESS: NEELEY/LONG/BANIPAL
DATE: 11/09/93 TIME: 1042 DIRECTION:
WAREHOUSE INTERIOR, SOUTHBAY.

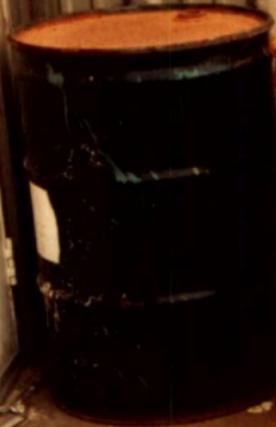
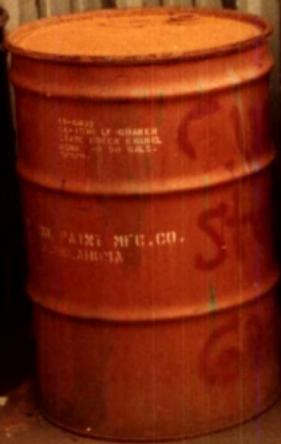
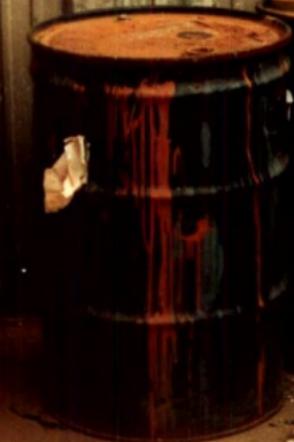
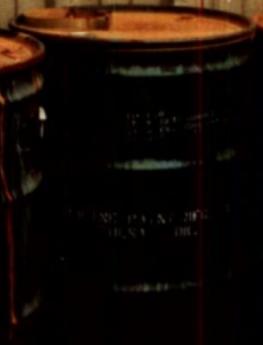
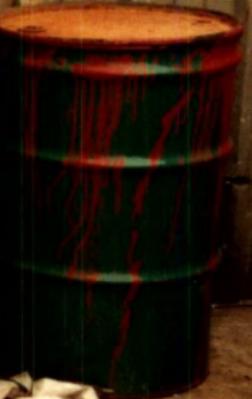
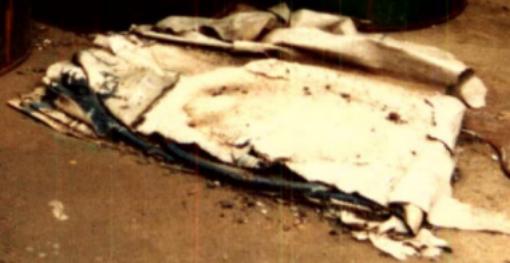
SITE NAME: TRI CONTAINER, INC. TOD# T06-9311-011
PHOTO# 201 PHOTOGRAPHER\WITNESS: NEELEY/LONG/BANIPAL
DATE: 11/09/93 TIME: 1050 DIRECTION: E
DRUMS OUTSIDE OF WAREHOUSE, SOUTHBAY CONTAINING PAINT WASTE.

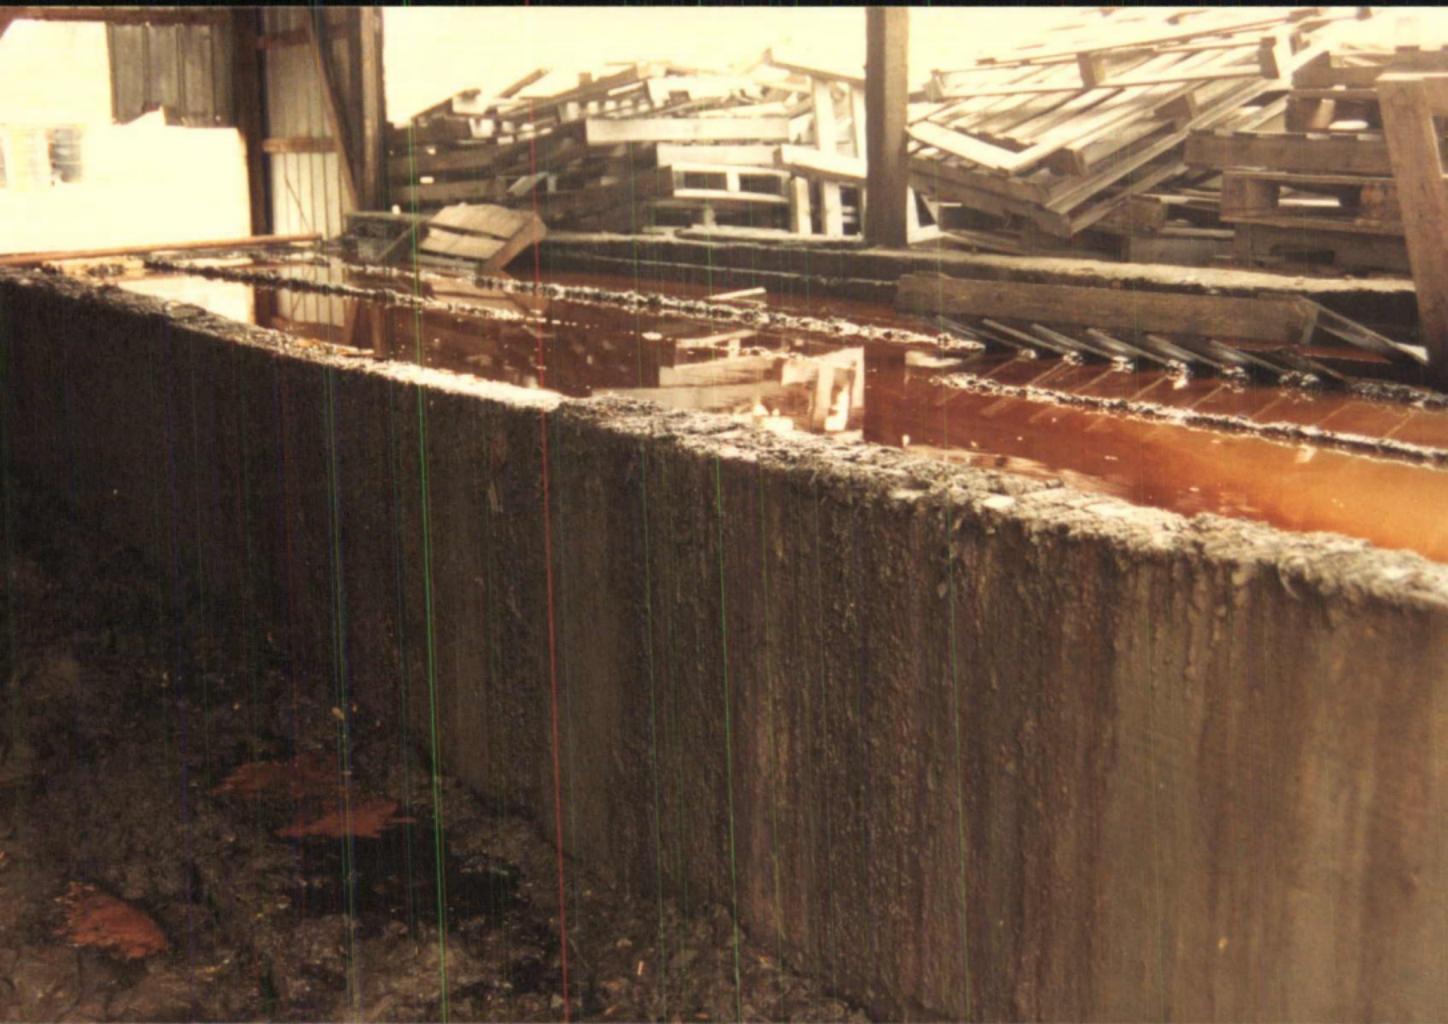
2-3

SITE NAME: TRI CONTAINER, INC. TOD #: T06-9311-011
PHOTO #: 203. PHOTOGRAPHER/WITNESS: NEELEY\LONG\BANIPAL
DATE: 11/09/93 TIME: 1055 DIRECTION: SW
DRUM WASH SHED. NOTE VATS AND SLUDGE (WASTE OIL?) ON FLOOR.

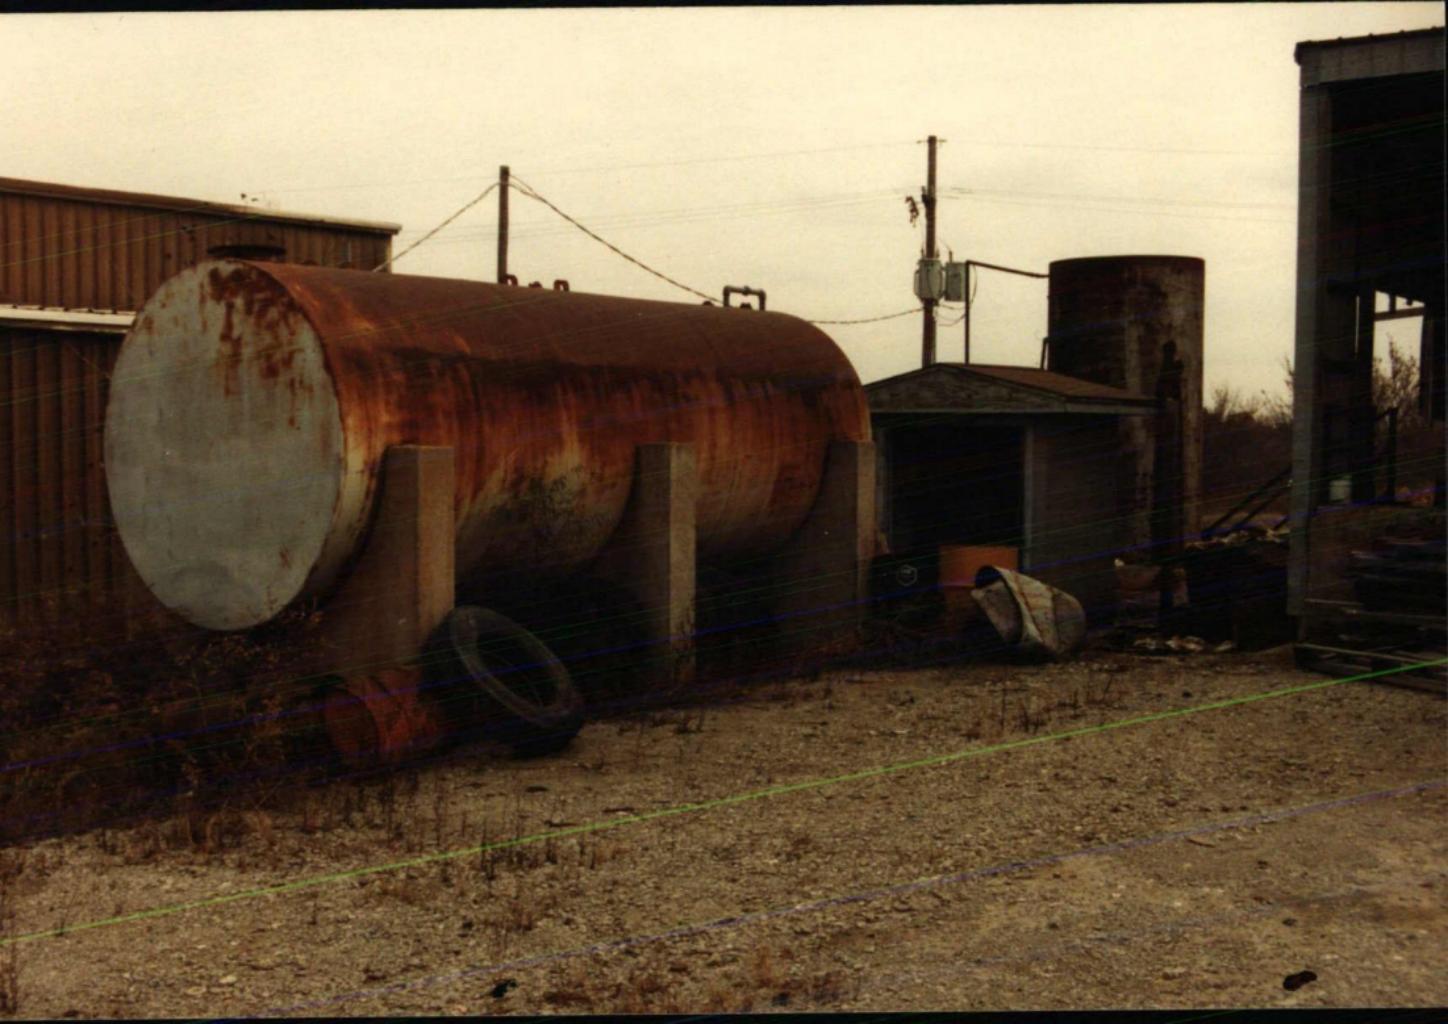
2-4

SITE NAME: TRI CONTAINER, INC. TDD#: T06-9311-011
PHOTO #: 206 PHOTOGRAPHER\WITNESS: NEELEY\LONG\BANIPAL
DATE: 11/09/93 TIME: 1058 DIRECTION: NE
TANK- 20,000 GALS ? SOUTH SIDE OF WAREHOUSE, SOUTHBAY.

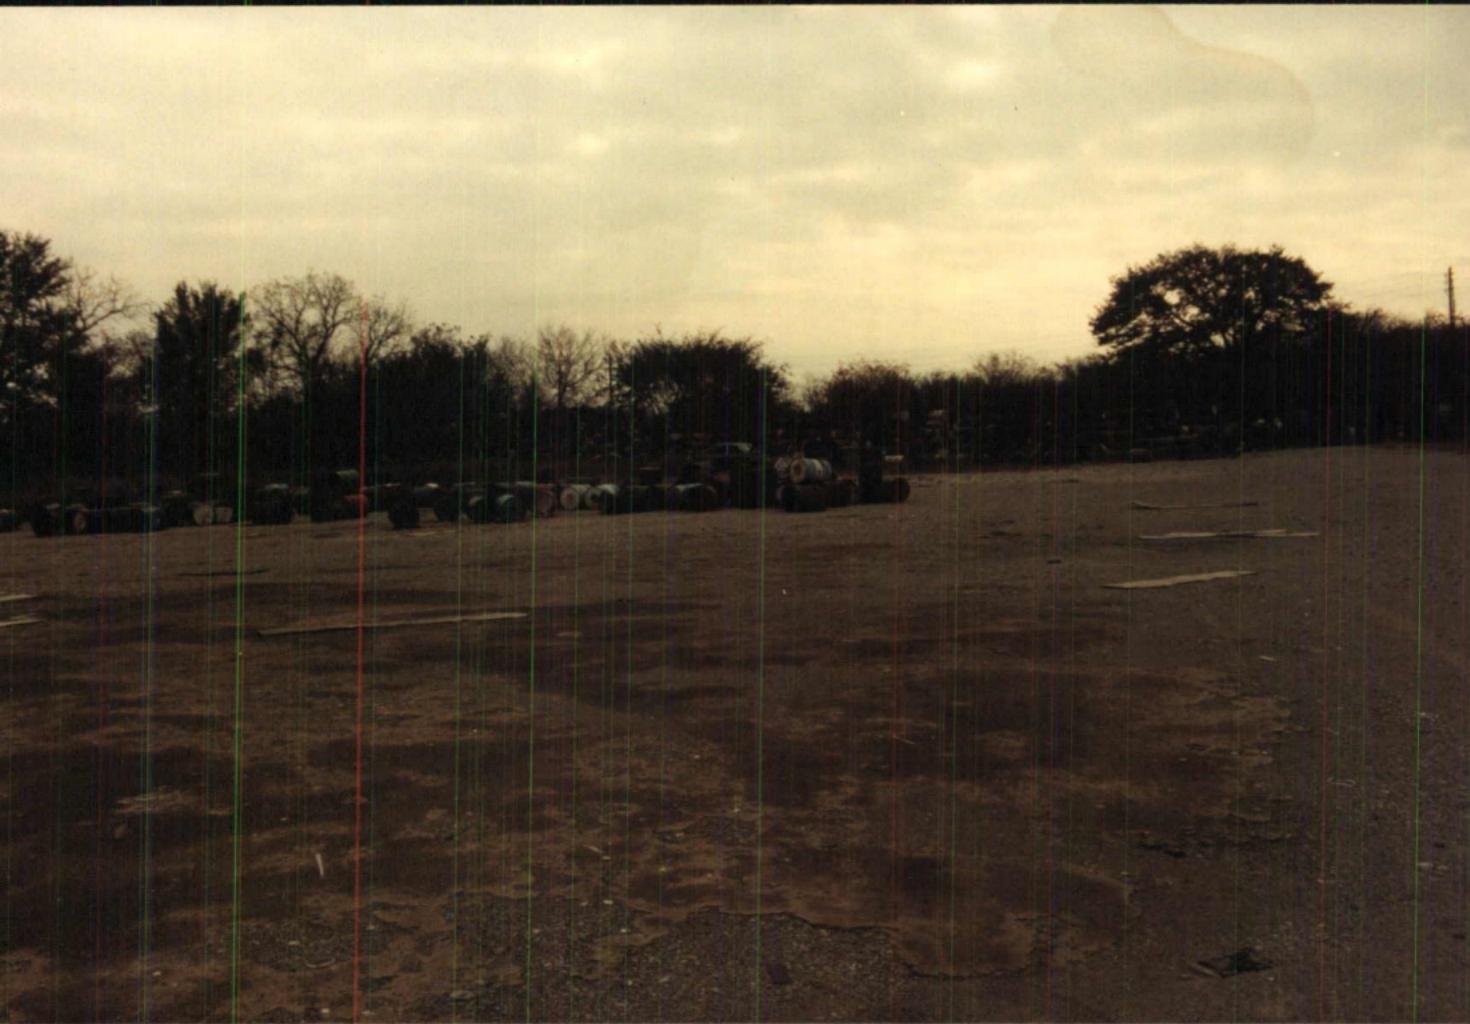
SITE NAME: TRI CONTAINER, INC. TDD# T06-9311-011
PHOTO# 208 PHOTOGRAPHER/WITNESS: NEELEY\LONG\BANIPAL
DATE: 11/09/93 TIME: 1110 DIRECTION: S
DRUMS STAGED IN GROUPS OR PILES. MOST DRUMS ARE EMPTY.

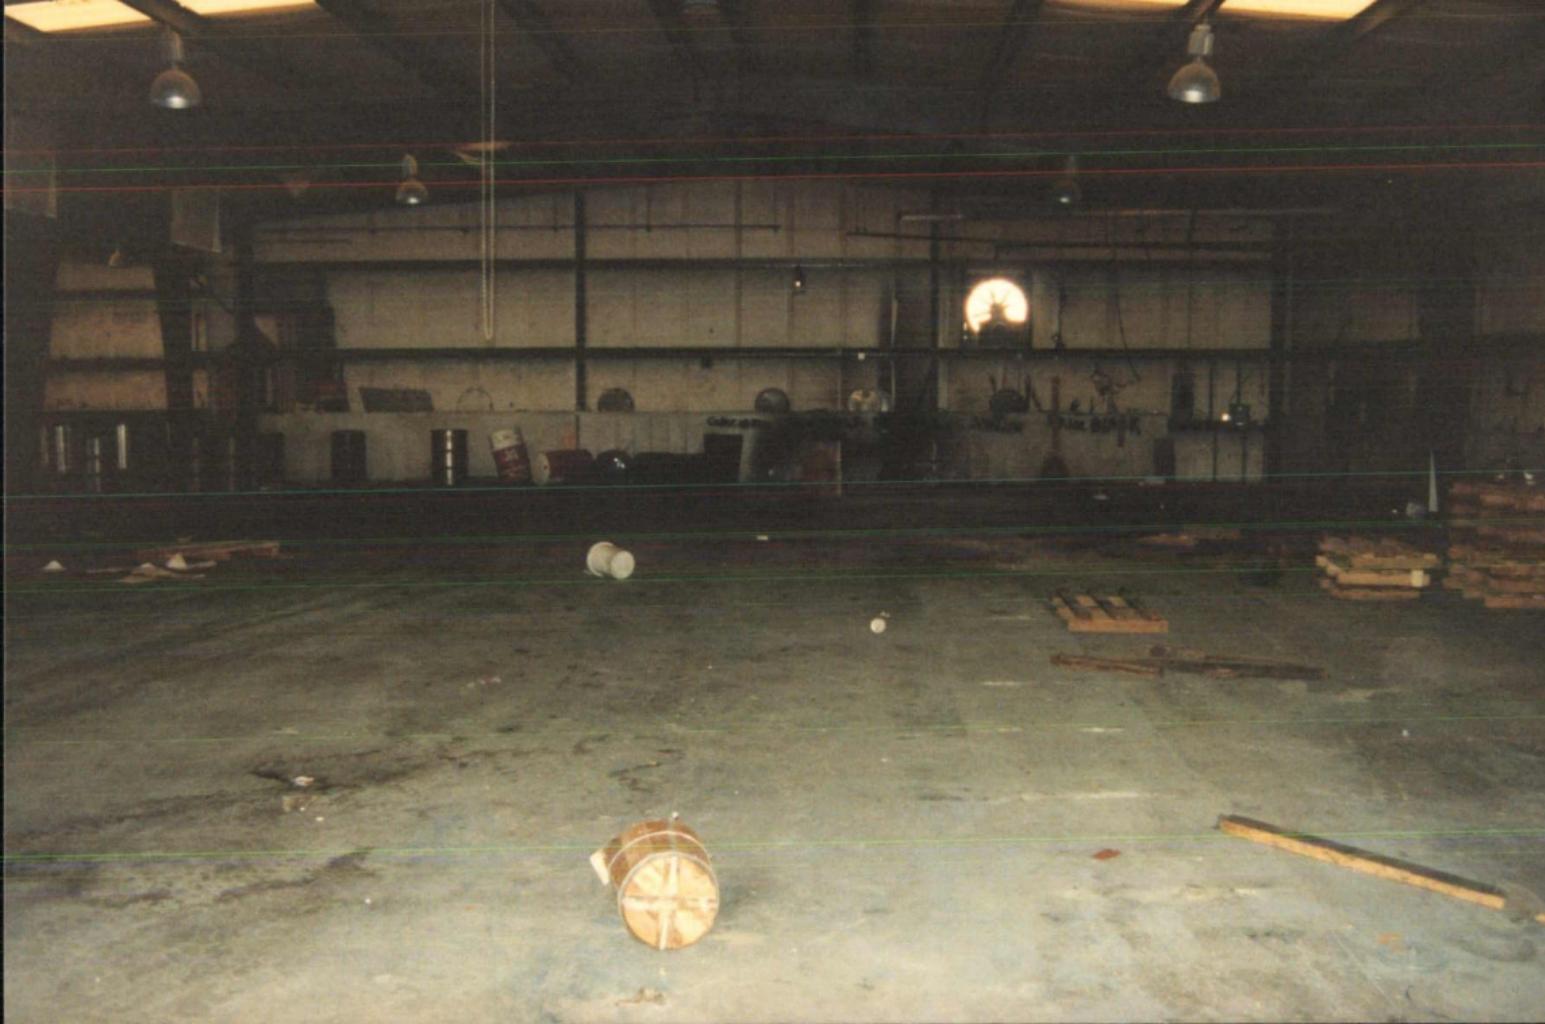
SITE NAME: TRI CONTAINER, INC. TOD#: T06-9311-011
PHOTO#: 303 PHOTOGRAPHER\WITNESS: NEELEY\LONG\BANIPAL
DATE: 11/09/93 TIME: 1207 DIRECTION:
WAREHOUSE INTERIOR, NORTHBAY.

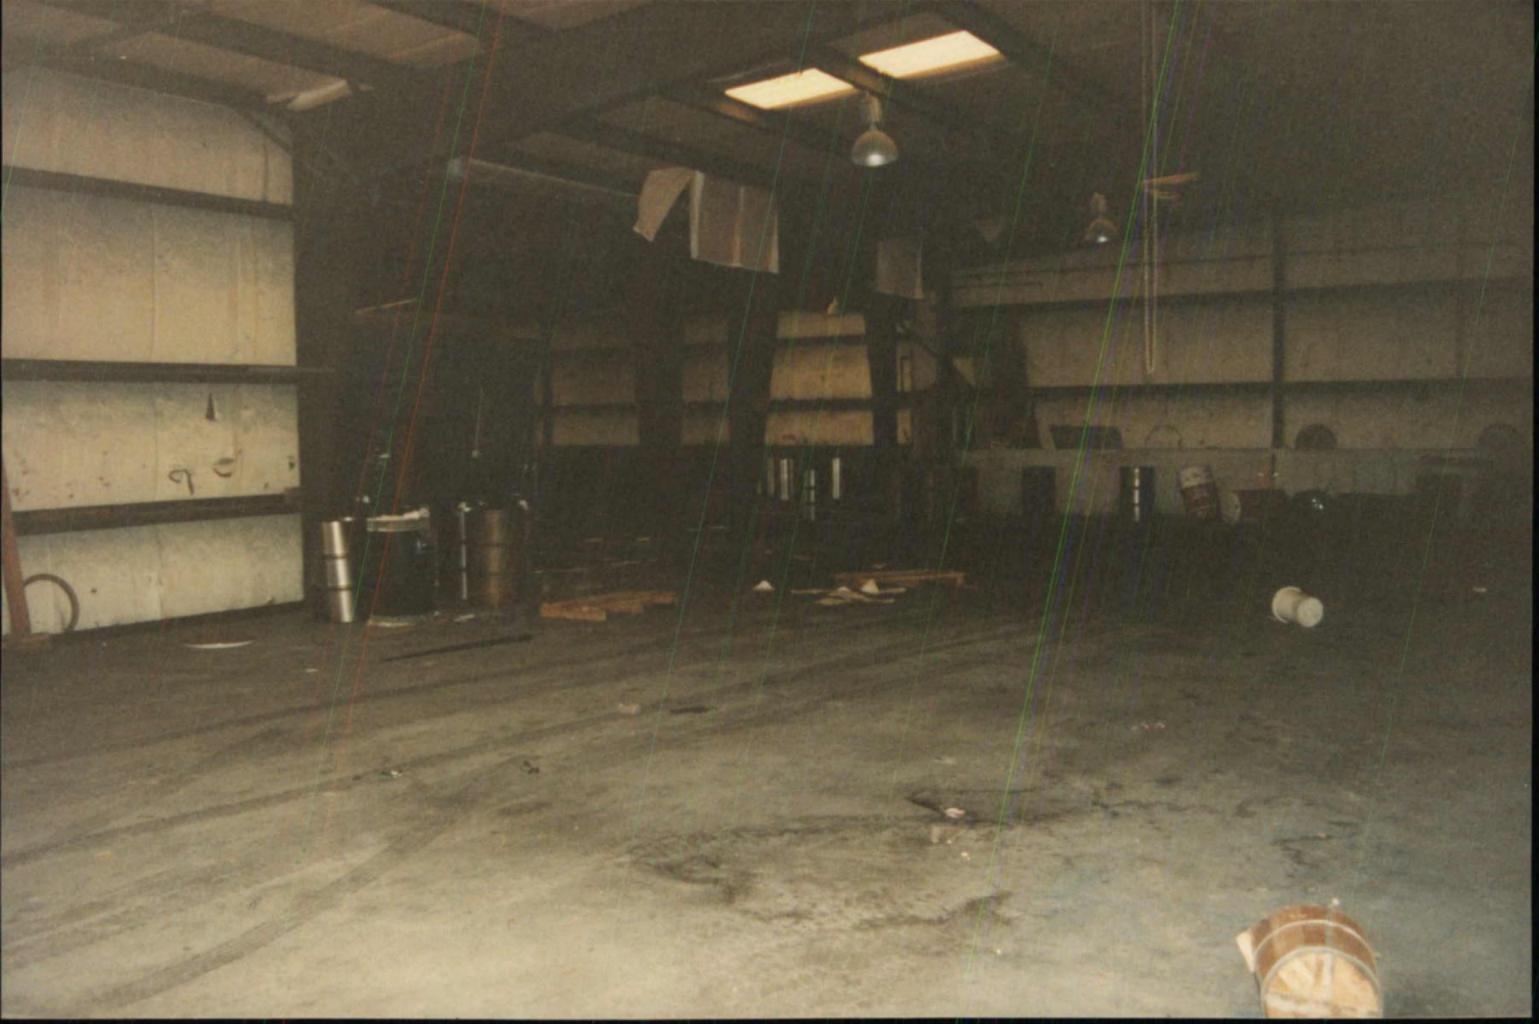
3-4

SITE NAME: TRI CONTAINER, INC. TOD#: T06-9311-011
PHOTO#: 304 PHOTOGRAPHER\WITNESS: NEELEY\LONG\BANIPAL
DATE: 11/09/93 TIME: 1207 DIRECTION:
WAREHOUSE INTERIOR, NORTHBAY.

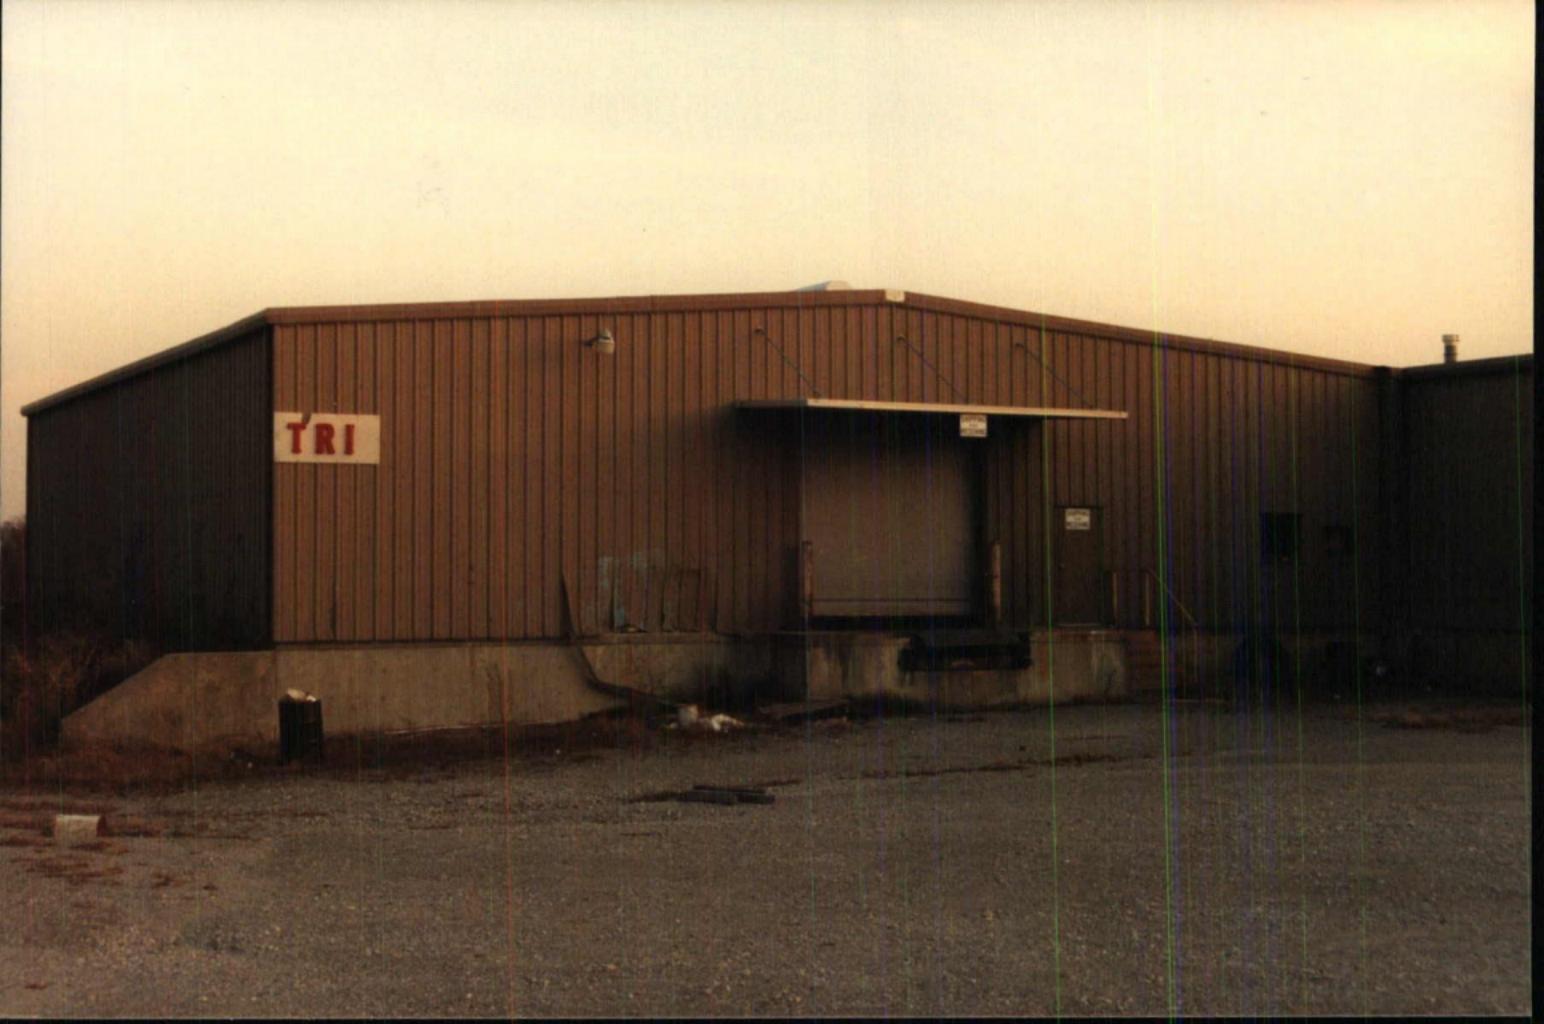
SITE NAME: TRI CONTAINER, INC. TDD#: T06-9311-011
PHOTO#: 308 PHOTOGRAPHER\WITNESS: NEELEY\LONG\BANIPAL
DATE: 11/09/93 TIME: 1711 DIRECTION: SE
LOADING DOCK FOR TRI CONTAINER, INC. WEST SIDE OF NORTHBAY
WAREHOUSE.

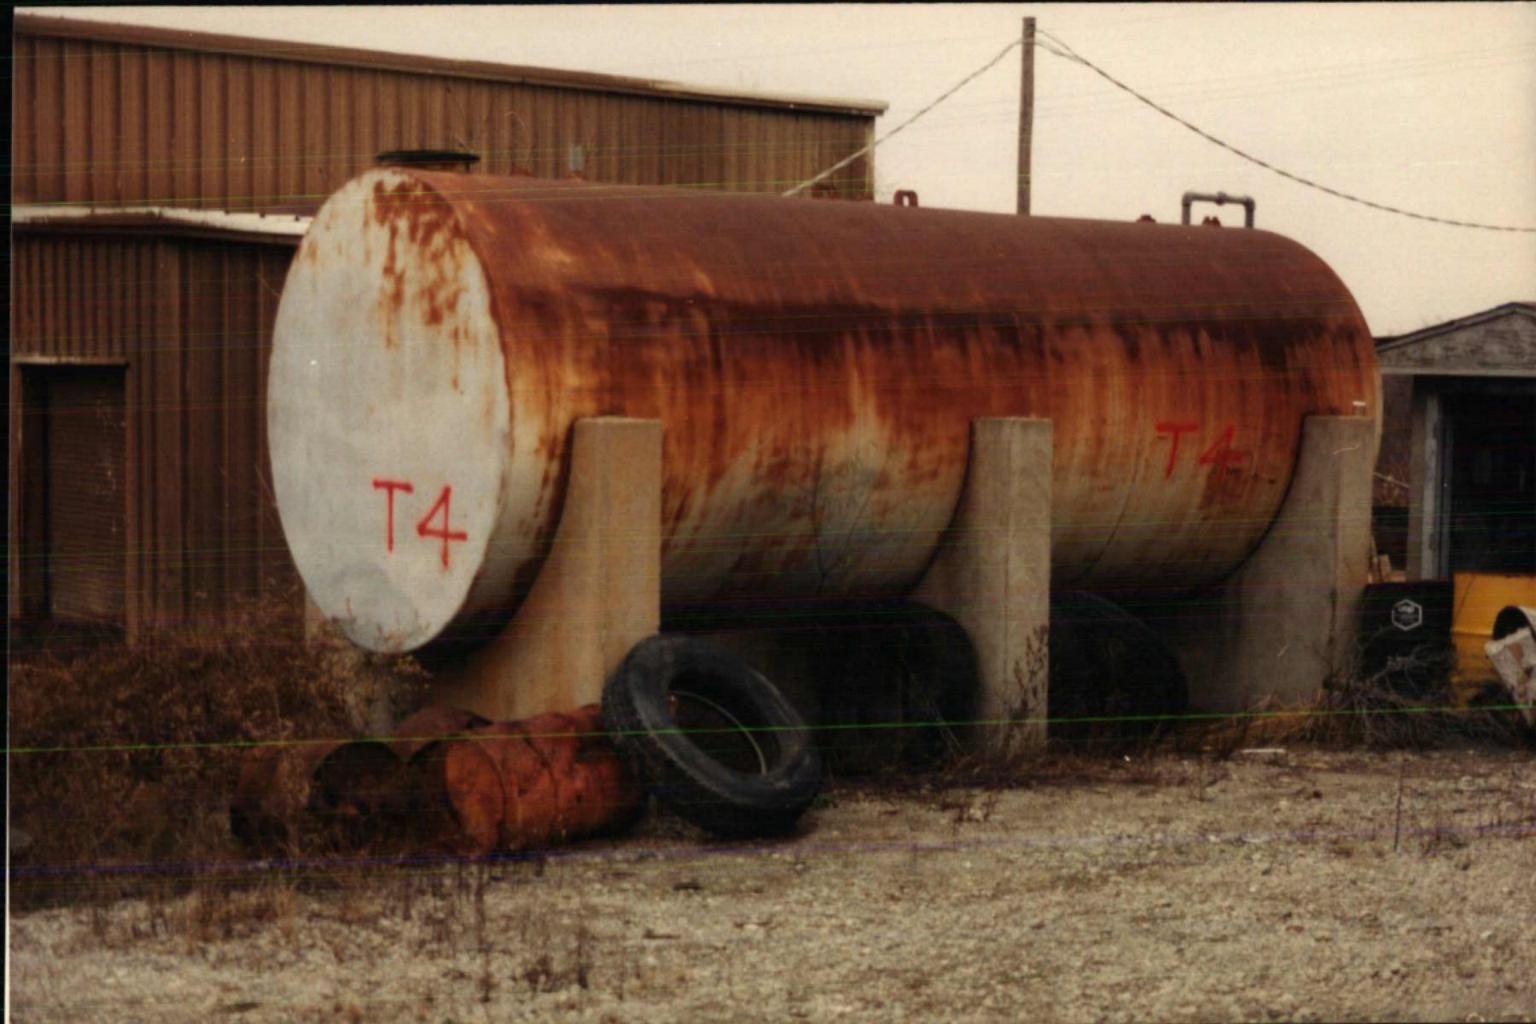
SITE NAME: TRI CONTAINER, INC. TOD#: T06-9311-011
PHOTO#: 420 PHOTOGRAPHER\WITNESS: NEELEY\LONG\BANIPAL
DATE: 11/16/93 TIME: 0905 DIRECTION: NE
TANK T-4

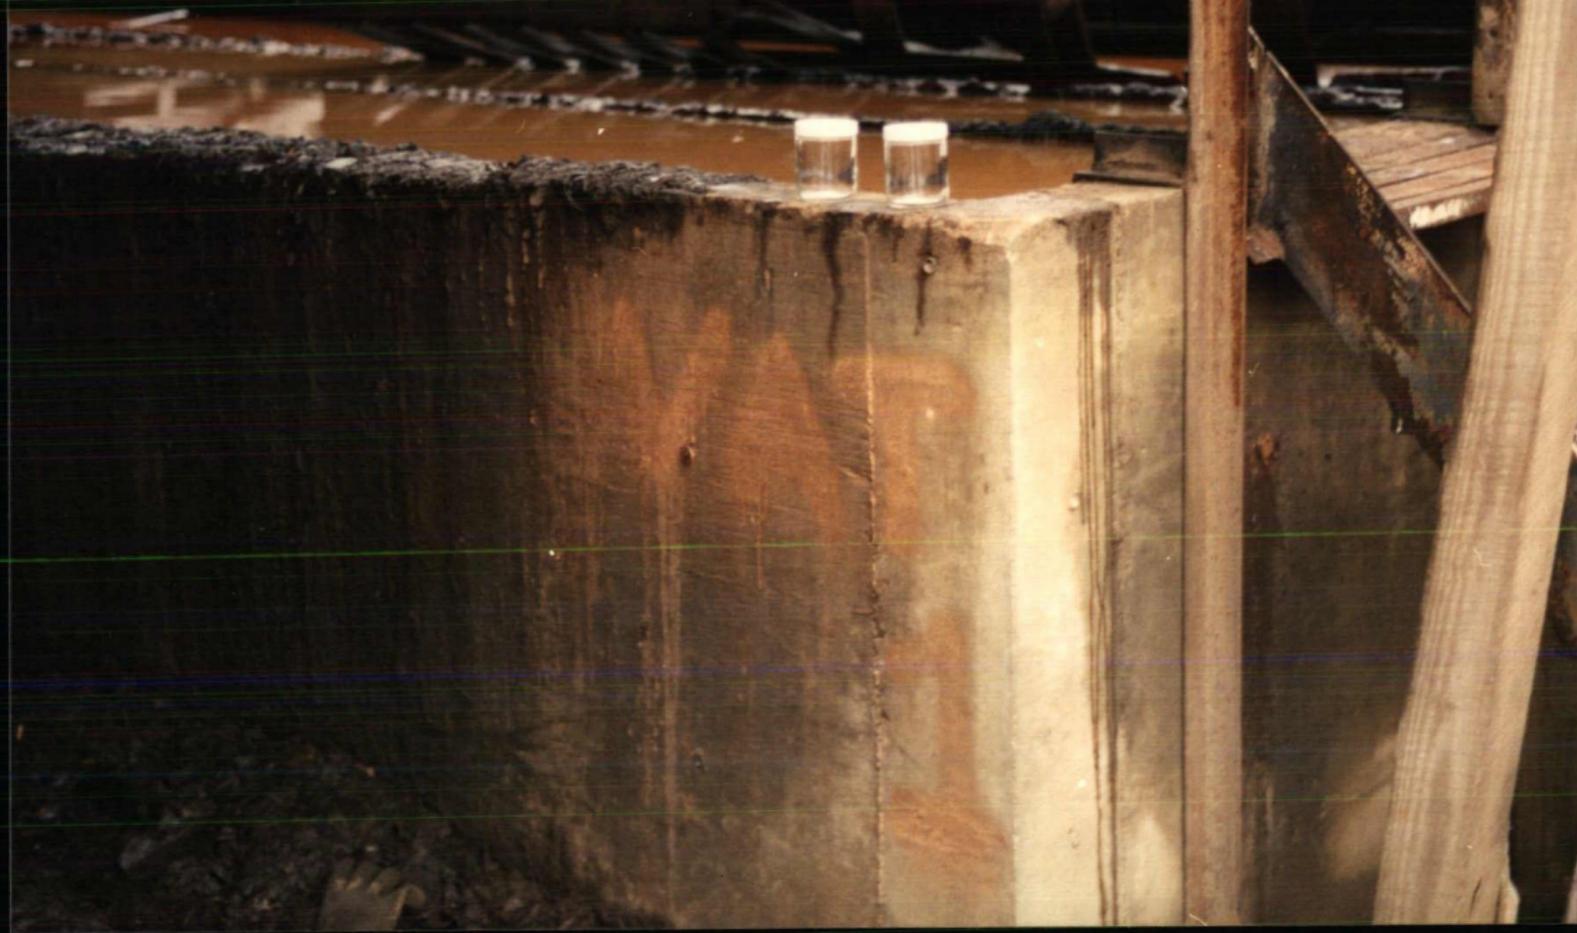
4-21

SITE NAME: TRI CONTAINER, INC. TDD# T06-9311-011
PHOTO#: 421 PHOTOGRAPHER\WITNESS: NEELEY\LONG\BANIPAL
DATE: 11/16/93 TIME: 0906 DIRECTION: SW
VAT READY FOR SAMPLING
